Manhole Inspection Summary

Manhole # S33CC1005MH

Location Address: **2 UNIVERSITY PKWY**

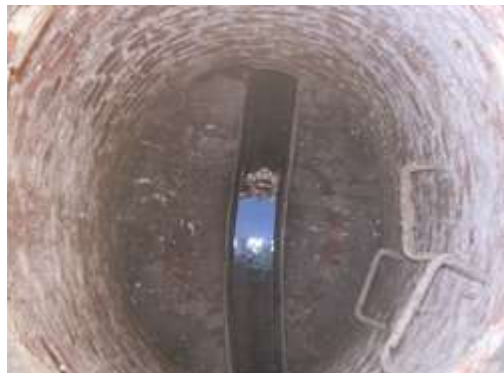
Top View

Adjustment deterioration and infiltration.
Barrel infiltration. Bench debris.

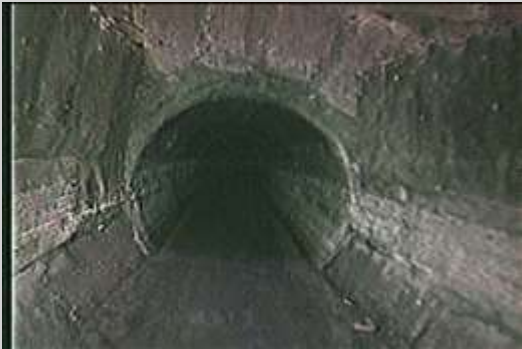
8 in. Circular Gravity Sewer Pipe Out @ 12 O'Clock

Infiltration: **Evidence** Pipe Seal Cond: **Unknown**

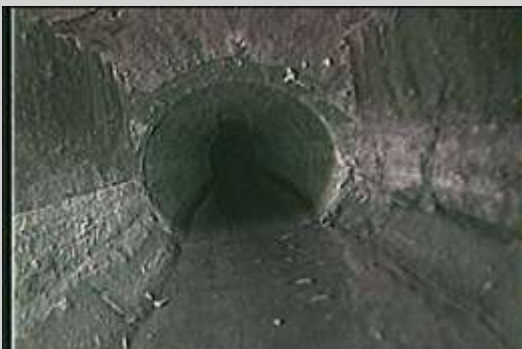
8 in. Circular Gravity Sewer Pipe In @ 6 O'Clock

Infiltration: **Evidence** Pipe Seal Cond: **Unknown**
